Report Number NTSB-AAR-82-8

Report Title Air Florida, Inc., Boeing 737-222, N62AF, Collision with 14th Street Bridge, Near Washington National Airport, Washington, D.C., January 13, 1982.

Organization Name National Transportation Safety Board Bureau of Accident Investigation Washington, D.C. 20594

Report Type Aircraft Accident Report January 13, 1982

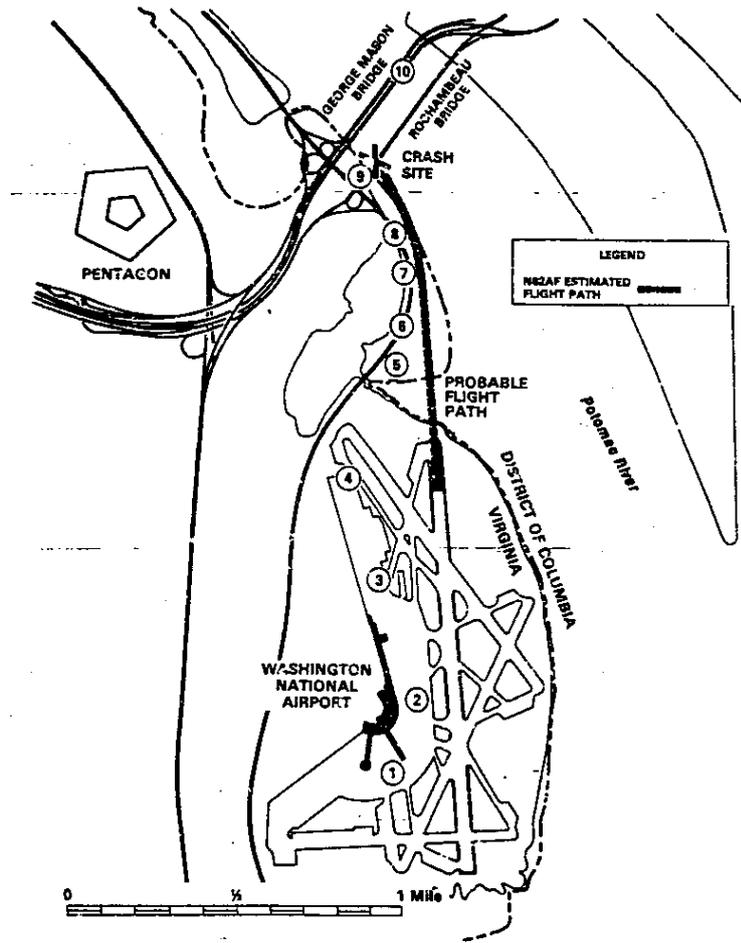
Figure 1.—Flightpath and witness locations.

Safety Board investigators interviewed more than 200 witnesses to establish the sequence of events from the start of the takeoff until impact, and more than 100 written statements were obtained. ([See figure 1](#) for witness locations and flightpath. Numbers correlate to the locations of 10 of the witnesses interviewed.)

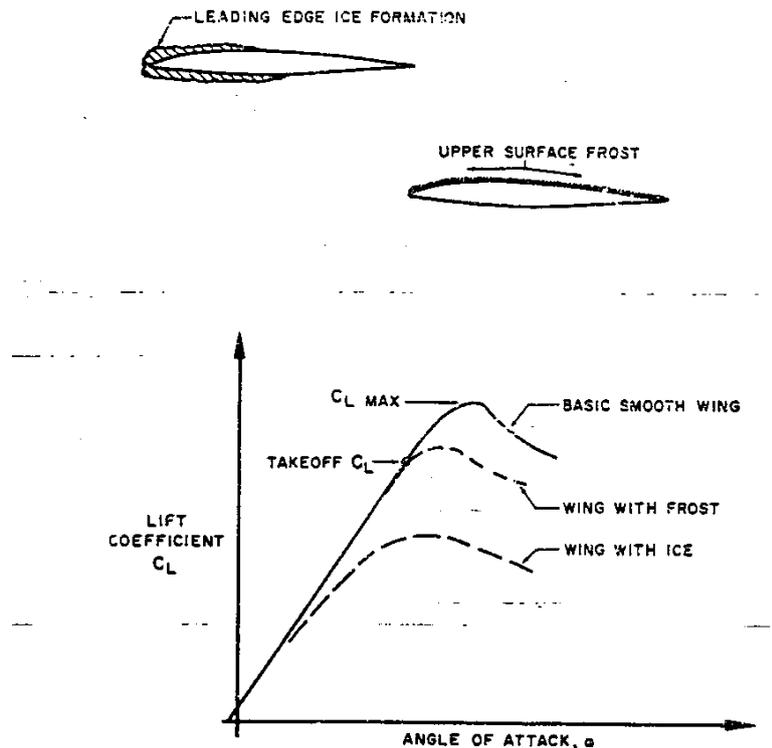
Most air carrier aircraft are equipped with a stickshaker or some other type of alarm to alert the pilot that his aircraft is approaching the stall angle of attack. In the B-737, the stickshaker is activated when a fuselage-mounted vane aligns itself with the airflow and reaches a preset angle of attack which is less than the stall angle of attack. The normal alarm margin is equivalent to about 10 percent of the stall airspeed. Since the stall warning activation is independent of the actual airflow conditions on the wing, the angle of attack at which it will activate is not affected by snow or ice contamination on the wing. However, if the wing's lift-producing efficiency is reduced by such contamination, the

aircraft will be maintaining a higher than normal airspeed when flown at the angle of attack at which the stickshaker will activate in order to compensate for the degraded efficiency of the wing. Thus, the stickshaker will activate at a higher-than-normal airspeed. Furthermore, the angle of attack margin, and thus the airspeed margin, between stall warning, stall buffet, and stall will be reduced significantly or negated entirely.
